Manhole Inspection Summary

Manhole # S01EE2001MH

Insp Date: **7/11/06 12:18 PM**

Location Address: **6405 WESTERN RUN DR**

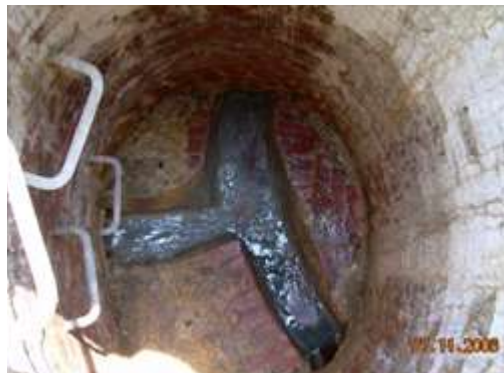
Top View

Corbel infiltration. Evidence of surcharge - Bench debris. Channel debris.

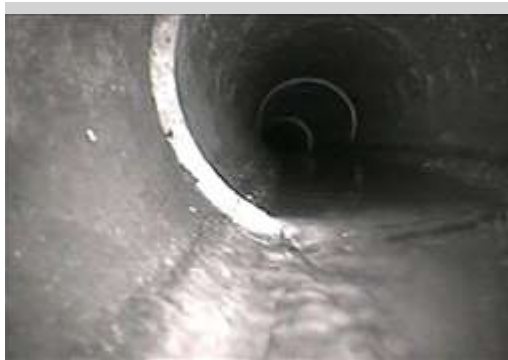
Inside the I9

Offset joint.

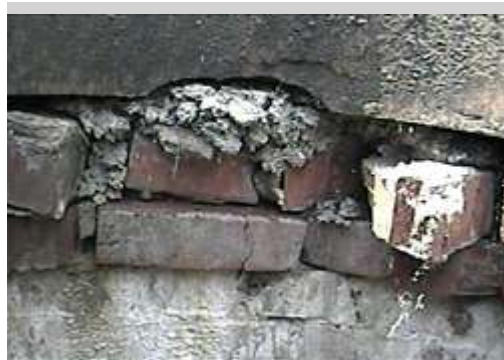
Defect

Frame leaks. Adjustment deterioration, loose brick and infiltration.

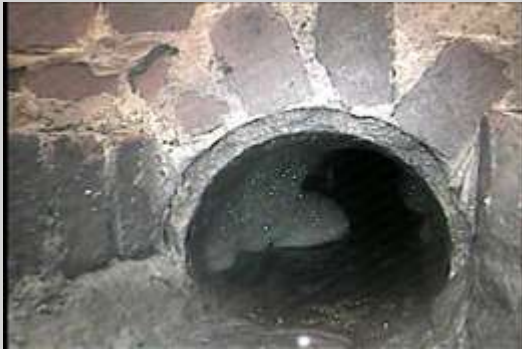
8 in. Circular Gravity Sewer Pipe Out @ 12 O'Clock

Infiltration: **Evidence** Pipe Seal Cond: **Unknown**

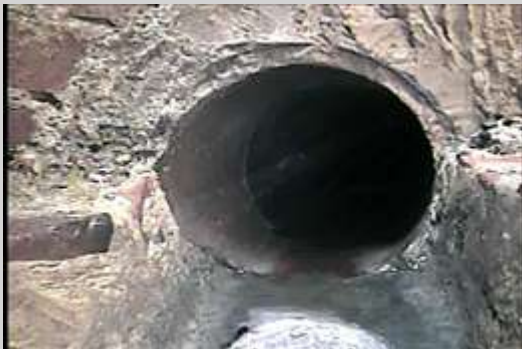
8 in. Circular Gravity Sewer Pipe In @ 6 O'Clock

Infiltration: **Evidence** Pipe Seal Cond: **Unknown**
